London Underground
Tube Lines
Health, Safety Quality and Environment
Formal Investigation Report

Joint investigation into the uncontrolled movement of a rail grinding unit between Highgate and Warren Street stations on the 13 August 2010

LUSEA Ref.: 20014989

Date of Issue: 8 December 2010

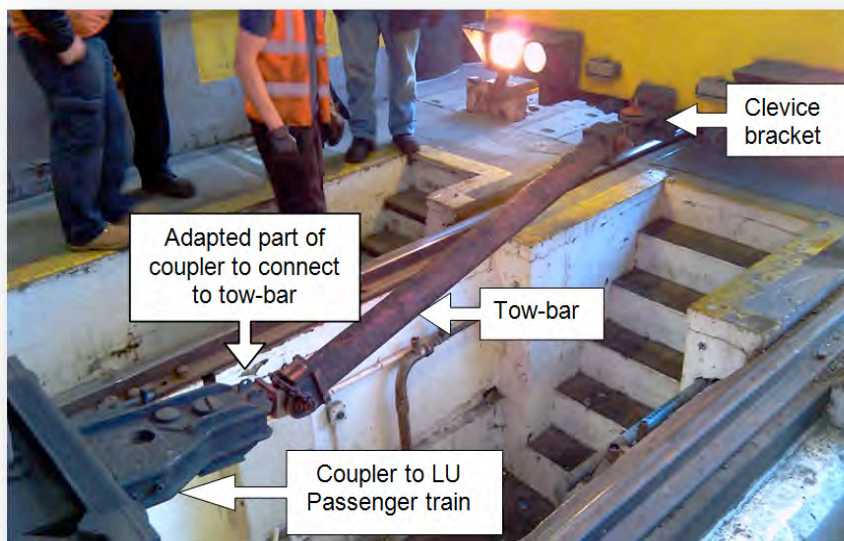
Fig 3: Emergency coupler attached to RGU and passenger train

- 8.1.4 The solution consisted of an LU coupler adapted to connect to a tow-bar and a tow-bar with fixings to couple to the RGU (see figure 3). The emergency coupler equipment was tested in the depot using a 'Schoma' diesel locomotive with an auto-coupler rather than the standard 'buck-eye' coupler. The testing took place on level track and did not include an emergency brake application to reflect operational conditions. It was not possible to test the emergency coupler using a passenger train as the emergency coupler was not approved for use on the operational railway. The findings of the tests in the depot were not recorded. The emergency coupler design, testing and approval were signed off by the Plant Approvals Engineer (using the applicable procedures and standards in place at the time). The approvals process did not identify the introduction of a single point of failure, nor consider the forces the emergency coupler would be exposed to during an emergency brake application by an assisting train. The plant approvals process did not link into the rolling stock approvals process for the RGU. Any use of chains, or any other secondary means of coupling, was not recorded in the OSP&I, Certificate of Technical Conformance (CTC) or Emergency Plan.

and the combined parts were halfway over to the left hand side end stop from the centre position. The coupled arrangement was also sloping toward the ground from the horizontal (see figure 3). The emergency lights were on in the train and the emergency vents were still running. There was no main line air but the traction air in the southern most car had been isolated. As a result of this evidence, the FIR panel is confident that the analysis of the events leading to the coupling failure is accurate.

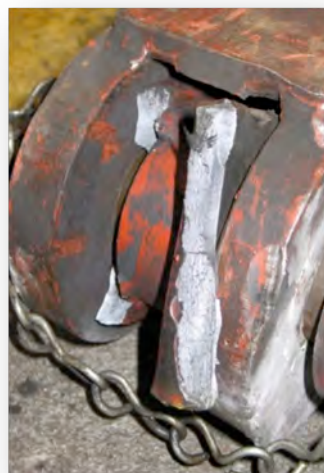
Fig. 4: Fracture face of the emergency coupler

- 8.2.1 The failed emergency coupler and tow bar have been examined by an LU Structural Engineer to assess the suitability of its design and the likely cause of failure. The emergency coupler and associated fixings were removed by the RAIB for examination. The fracture faces of the emergency coupler have been studied jointly with witness statements and information from the passenger train data recorder (which records details of train operation). The FIR panel consider that the tow bar failed when it went into a compressively loaded condition during an emergency brake application on the passenger train. It was also noted that the RGU inter-car couplings also became distorted under the forces from the emergency brake application on the passenger train. The FIR panel concluded that the emergency braking compressive forces had not been considered during the coupler design or approval stages.

- 8.2.2 The condition of the fracture faces confirm that it was a rapid fracture and that there is no evidence of the features that are usually associated with fatigue based failures that could have been identified through maintenance (e.g. 'beach marks' or dirt ingress, see figure 4 showing bright fracture faces). Furthermore, the emergency coupler and tow bar have been used five times, including this incident, this is believed to be insufficient to provide the significant number of load cycles required to cause a fatigue related failure. The distortion of the material also suggests that a significant bending load was involved in the failure. This is considered to be with the emergency coupler at the limit of its lateral extension and a compressive force from the tow bar during the emergency brake application. There are inaccuracies in the strength and load calculations provided by the emergency coupling supplier. For conventional rail vehicles, a normal coupler is required to be able to withstand a specified compressive force of 1500 tonnes. Whilst not directly comparable, it is indicative that the design strength of the tow-bar is 36.5 tonnes.

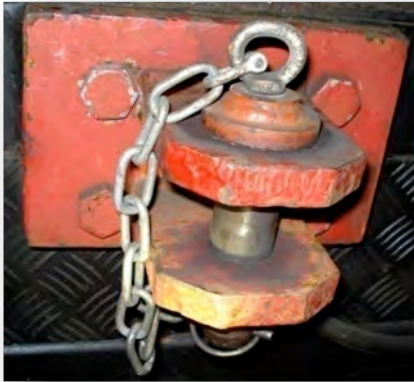
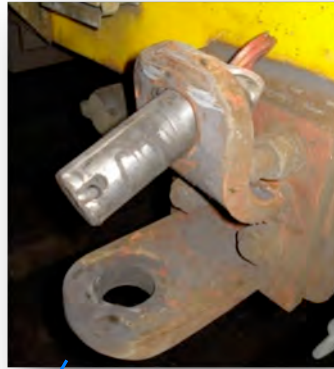
Figs. 5 & 6 Intact and damaged coupling points on the RGU

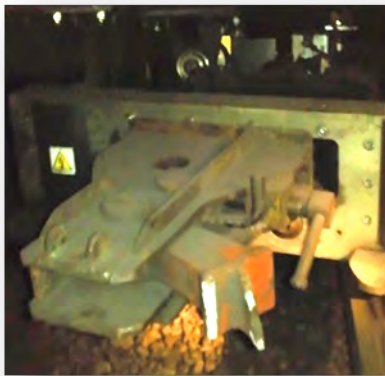
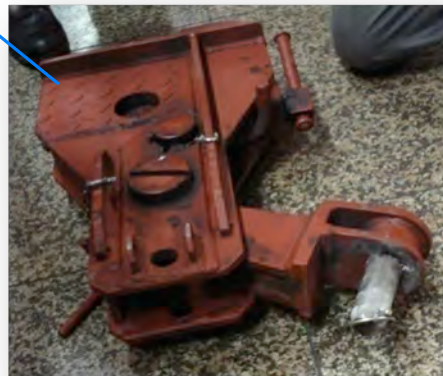
Fig 8 & 9 Damaged and intact coupler used to connect tow-bar to LU passenger train (note point of failure in image on the left)

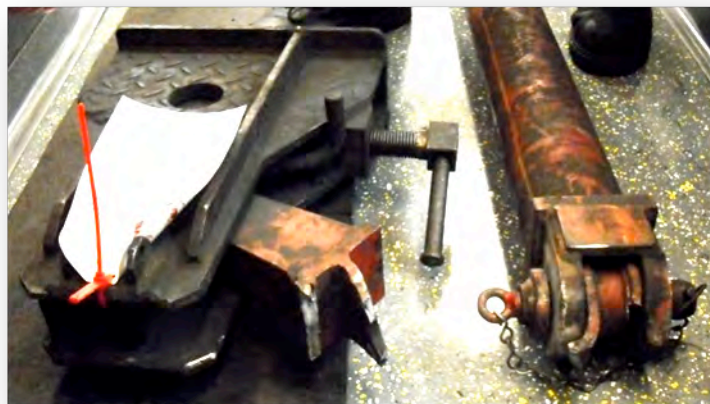
Fig 10 emergency coupler and tow-bar showing point of failure (note bent metal on tow-bar implying a 'tear' rather than fatigue shear)
