London Underground
Tube Lines
Health, Safety Quality and Environment
Formal Investigation Report

Joint investigation into the uncontrolled movement of a rail grinding unit between Highgate and Warren Street stations on the 13 August 2010

LUSEA Ref.: 20014989

Date of Issue: 8 December 2010

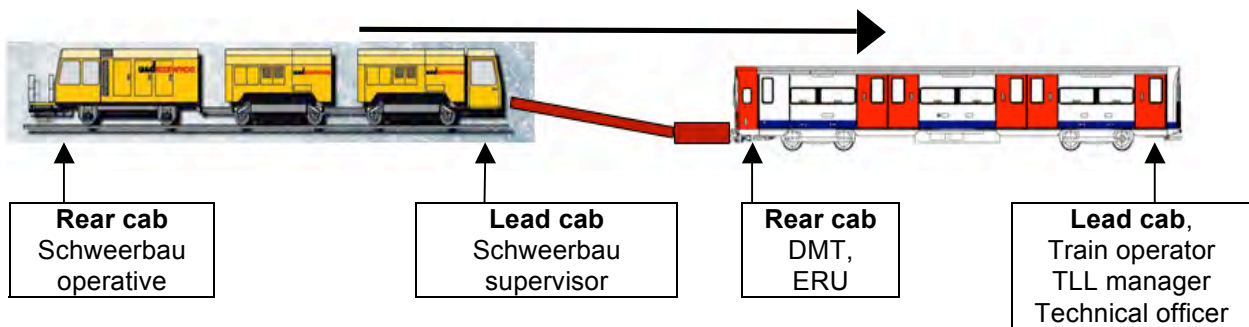
Figure 1: Locations of people on the coupled trains

7.1.4 The coupled trains were towed by the passenger train with the Train Operator, Tube Lines (TLL) manager and TO in the leading cab and the ERU manager and DMT in the rear cab. The Schwebbau operatives were in the front and rear cab of the RGU. It was agreed that in the event of a problem, the Schwebbau operatives would flash a torch at the staff in the rear cab of the passenger train, approximately 3 metres in front. All staff with Connect radios were on the passenger train and no Connect radio was available for the Schwebbau operatives on the RGU who are not issued with Connect radios or trained in their use as they normally have other Tube Lines staff with them who do have Connect radios.

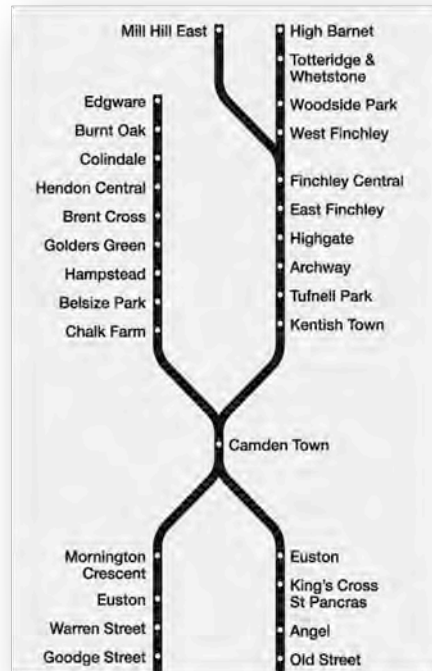
Figure 2: Map of the Northern Line

7.2.2 Southbound train 107 at Archway, which had just entered service from Archway sidings, was informed of the situation and instructed by Service Control to non-stop at stations until further notice. Service Control routed Train 107 onto the Bank branch of the Northern line and the RGU was routed onto the Charing Cross branch. This option was chosen for expediency as the points self 'normalise' to the Charing Cross branch. At the same time the NOC was informed of the incident by Service Control and requested to arrange for support from the emergency services. The Camden Town Station Supervisor was instructed to clear customers from the southbound Charing Cross branch platform.

7.2.3 An attempt was made to derail the RGU by setting 18 points at Mornington Crescent against the path of the RGU. A derailment would have caused significant asset damage but the FIR panel concluded that this was preferable to the uncontrolled movement continuing unchecked. The potential outcomes of the incident were a collision either with another train or with the infrastructure, either of which might have resulted in serious injuries or fatalities (Service Control were not aware that the Schweerbau operatives were no longer on the RGU). The derailment attempt failed to stop the RGU as it split and ran through the points. However, this slowed down the RGU which was being monitored by Service Control on signalling diagrams and station CCTV. Service Control then planned to route the RGU into Kennington sidings and arrangements were made to move two passenger trains at Tottenham Court Road and Embankment out of the path of the RGU, and by the time that the RGU passed through Euston station, the Charing Cross branch southbound was clear of passenger trains.
